Minimizing Water Intrusion Through Roof Vents in High-Wind Regions

HOME BUILDER'S GUIDE TO COASTAL CONSTRUCTION

Technical Fact Sheet No. 7.5

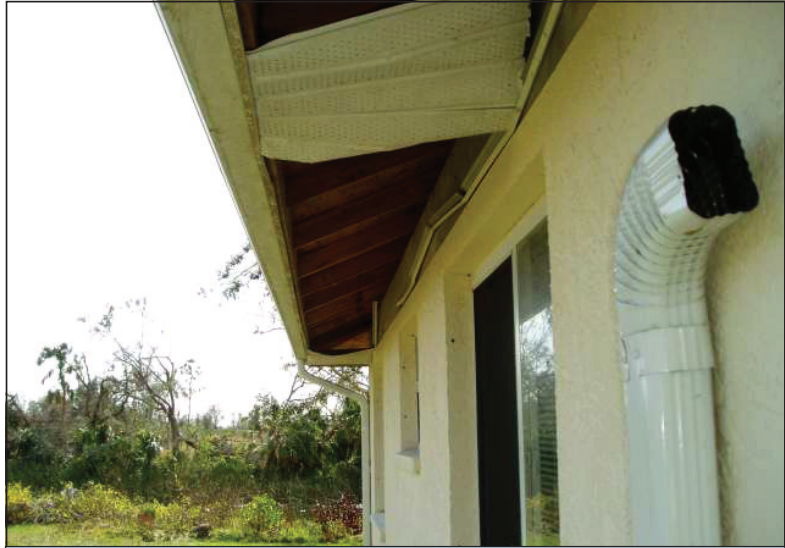
Figure 1. Missing soffit material.

- It is important to keep the soffit material in place. While some water can be blown into the attic through almost any type of soffit vent, the amount of water intrusion increases dramatically when the soffit material is missing (Figure 1).
- Plywood or wood soffits are generally adequately anchored to wood framing attached to the roof structure and/or the walls. However, it has been common practice for vinyl and aluminum soffit panels to be installed in tracks that are frequently very poorly connected to the walls and fascia at the edge of the roof overhang. When these poorly anchored soffits are blown off, water intrusion increases significantly. Properly installed vinyl and aluminum soffit panels are fastened to the building structure or to nailing strips placed at intervals specified by the manufacturer.

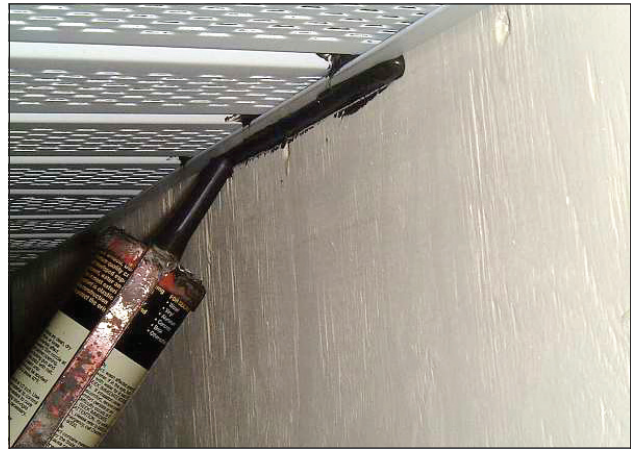
Figure 3. Applying a bead of sealant. (Note: Black sealant was used so that it would be visible in the photograph. Normally a matching sealant color would be used.)

If the inspection indicates a poorly attached soffit, the best way to ensure that the soffit material is adequately anchored in place is to remove it and install adequate wood blocking to allow solid anchorage of the soffit material. In some cases, it may be possible to remove the soffit material and reinstall it. However, it is also likely that some or all of the material will need to be replaced, so make sure that it can be matched before it is removed. Short of removing and properly reinstalling the soffit material, testing has shown that the anchorage can be greatly improved by applying a bead of sealant (Figure 3) along the bottom edge of the wall channel to adhere it to the wall surface below followed by applying large dabs of sealant in indentations between the soffit panels and the wall channel at one end (Figure 4) and the fascia flashing at the other end. Surfaces receiving sealant should be cleaned in order to facilitate bonding. Extra resistance can be gained by installing screws that mechanically tie the soffit panels to both the fascia flashing and to the wall channel (Figure 5). Note that use of sealant is a remedial measure only and is not a substitute for proper installation and fastening of soffits in a new installation.

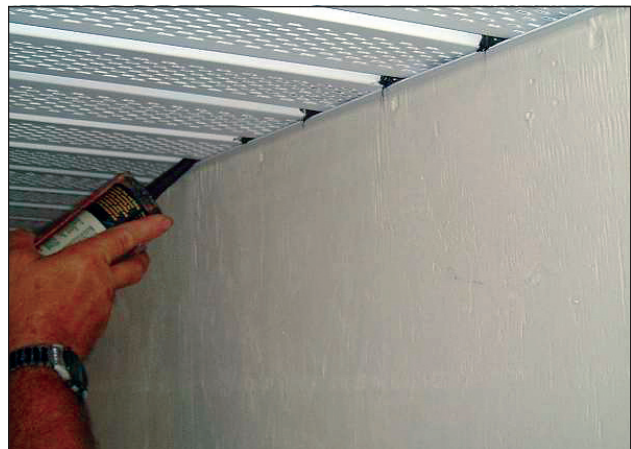
Figure 4. Applying dabs of sealant.

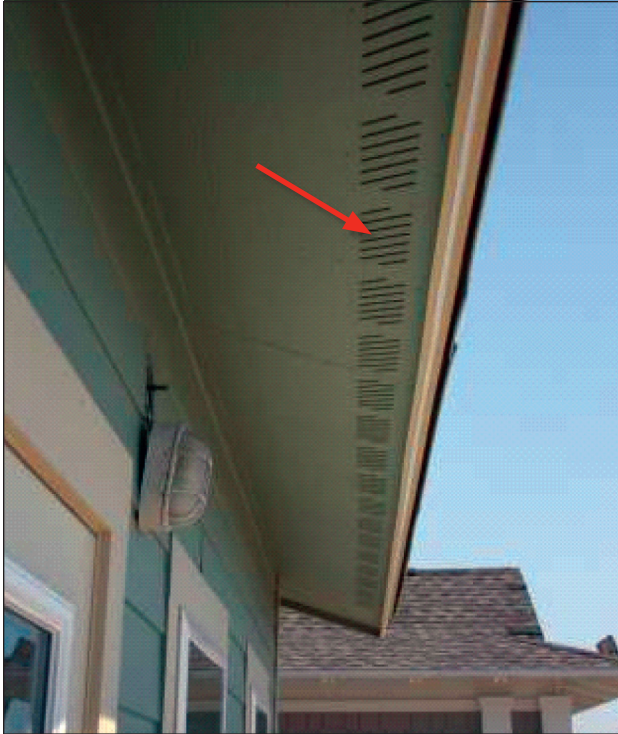
Figure 6. Fiber cement soffit with ventilation slots (red arrow).

Wind-driven rain penetration: Currently there is no adequate standard test method to evaluate the potential for wind-driven rain to enter attics through soffit vent openings, such as those shown in Figure 6. To avoid water entry at soffit vents, options include eliminating soffit vents and providing an alternate method for air to enter the attic, or design for an unvented attic. Another approach is to place filter fabric (like that used for heating, ventilation, or cooling [HVAC] system filters) above the vent openings; however, such an approach needs to be custom designed.

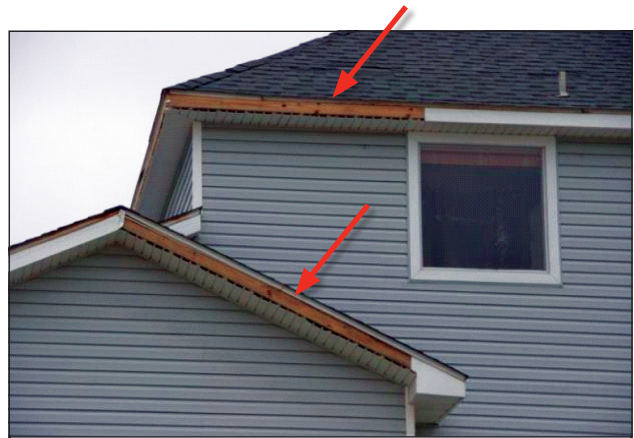
Figure 7. Loss of fascia cover exposes ends of vinyl soffit to direct entry of wind-driven rain.

Fascia cover: Field investigations after Hurricane Ike showed many cases where the aluminum fascia cover (fascia cap) from the fascia board was blown off (Figure 7). The fascia cover normally covers the ends of vinyl and aluminum soffits. When the fascia cover is blown off, the ends of the soffit panels are exposed to wind and wind-driven rain.

The IRC currently has no guidelines for the installation of fascia covers. Aluminum fascia covers are typically tucked under the roof drip edge and face-nailed every few feet. More frequent nailing would help secure the fascia cover, but would also inhibit normal thermal movement, which can cause unattractive warping and dimpling of the cover. Vinyl fascia covers are available, which are attached to a continuous strip of utility trim placed underneath the drip edge. This provides a somewhat more secure, continuous attachment and allows for thermal movement. Aluminum fascia covers can also be field notched and installed with utility trim.

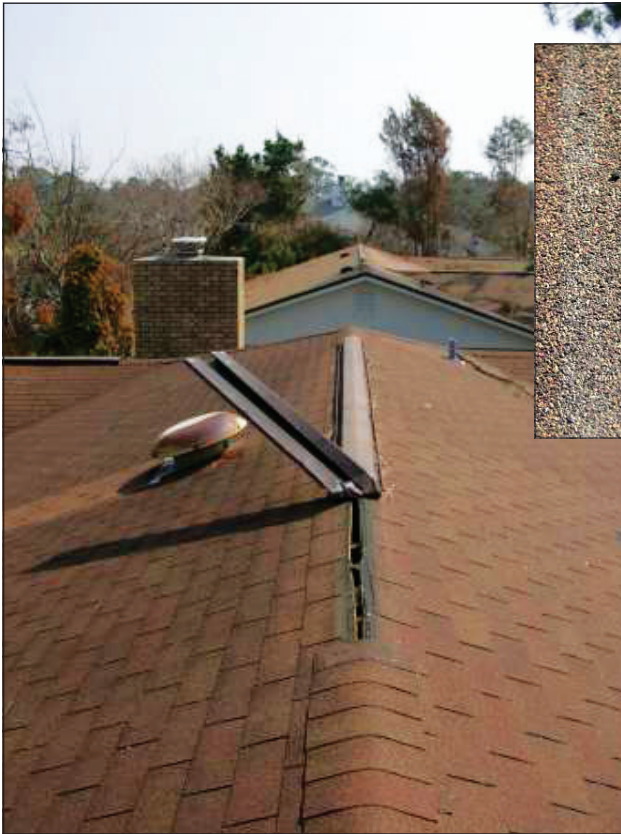
Figure 8. This metal ridge vent was attached with widely spaced roofing nails.

- Ridge vents are frequently fastened down using ordinary roofing nails since these are normally handy. It is fairly common to find ridge vents dislodged or blown off during a hurricane (Figure 8). Even a partially dislodged ridge vent can begin to act like a scoop that collects wind-driven rain and directs it into the attic.
- Most roofing manufacturers now make ridge vents that have passed wind-driven water tests. They are identified as having passed Florida Building Code's Product Approvals or Testing Application Standard (TAS) 100(A). Typically, they include a baffle in front of the vent tubes that provide the passageway for hot attic gases to escape. This baffle is intended to trip any flow of wind and water blowing up the surface of the roof and deflect it over the top of the roof ridge.

When ridge venting is being added to a roof that previously did not have it, it is necessary to cut a slot through the decking. When doing so, it is important to set the depth of the saw blade so that it only slightly projects below the bottom of the decking. At the residence shown in Figure 8, the saw blade cut approximately 1 1/2 inches into the trusses and cut a portion of the truss plate (red arrow).

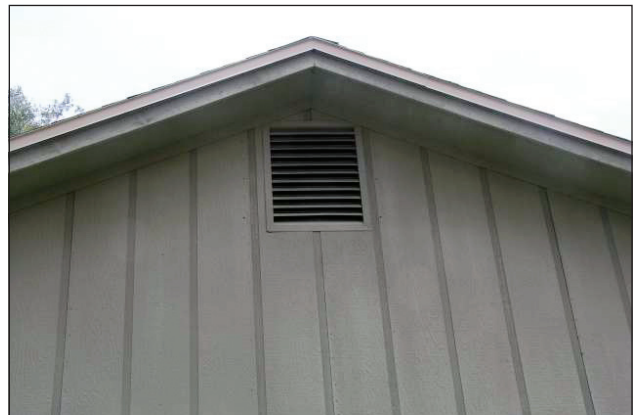
Figure 9. Gable end vent.

- Virtually all known gable end vents (Figure 9) will leak when the wall they are mounted on faces into the wind-driven rain. The pressures developed between the outside surface of the wall and the inside of the attic are sufficient to drive water uphill for a number of inches and, if there is much wind flow through the vent, water carried by the wind will be blown considerable distances into the attic.

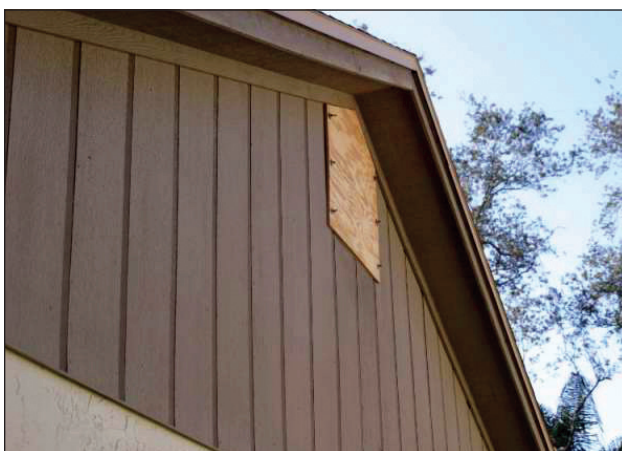
Figure 10. Shuttered gable end vent.

If it is practical and possible to shutter gable end vents from the outside of the house, this is the preferable way to minimize water intrusion through gable end vents (Figure 10). Install permanent anchors in the wood structure around the gable vent and pre-cut, pre-drill, and label plywood or other suitable shutter materials so that they are ready for installation by a qualified person just before a storm approaches. If installation of shutters from the outside is difficult because of the height or other considerations, but there is access through the attic, the gable vent opening can be shuttered from the inside. However, careful attention needs to be paid to sealing around the shutter and making sure that any water that accumulates in the cavity can drain to the outside of the house and not into the wall below.

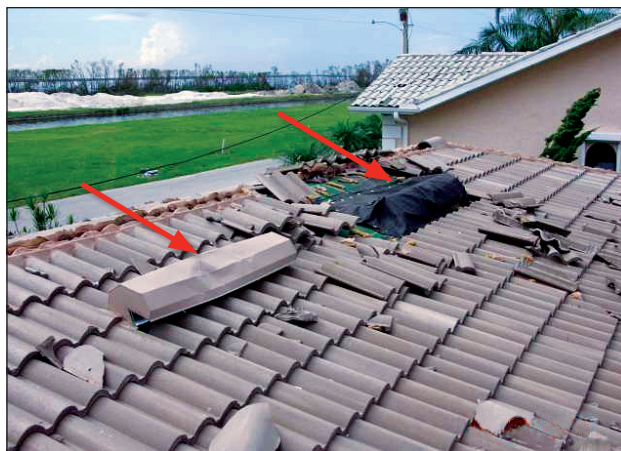
Figure 11. Two off-ridge vents are shown in this photograph. The vent that is covered with roofing felt flipped up and allowed a substantial amount of water to enter the residence. Carpeting, kitchen cabinets, and a large amount of gypsum board had to be replaced because of the water intrusion.

Poorly anchored off-ridge vents can flip up and become scoops that direct large amounts of wind-driven rain into the attic (Figure 11).

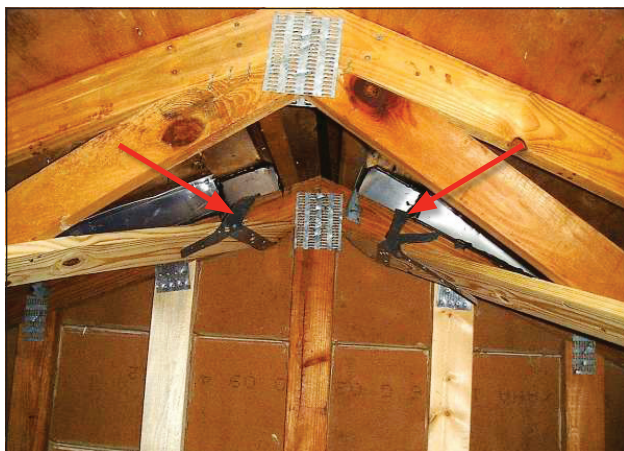
Figure 12. Metal plugs (red arrows) in gable rake vents.

The best solution if venting provided by the gable rake vents is not needed is to simply plug them up with metal flashing (Figure 12) or pieces of wood that are cut and anchored. They should be well attached and completely seal as many of the openings as possible

and particularly those near the gable peak. Sealant can be used to seal around the edges of the metal or wood plugs.

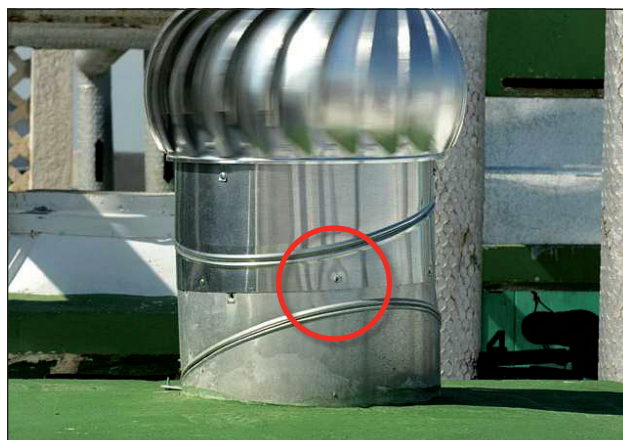
Figure 13. This turbine head is attached to the standpipe with dimple punches. Sheet metal screws should be added to strengthen the connection.

Check any turbines to make sure that the stand pipes are not loose and that the turbine head is anchored to the stand pipe by sheet metal screws and not simply by a friction fit (Figure 13).

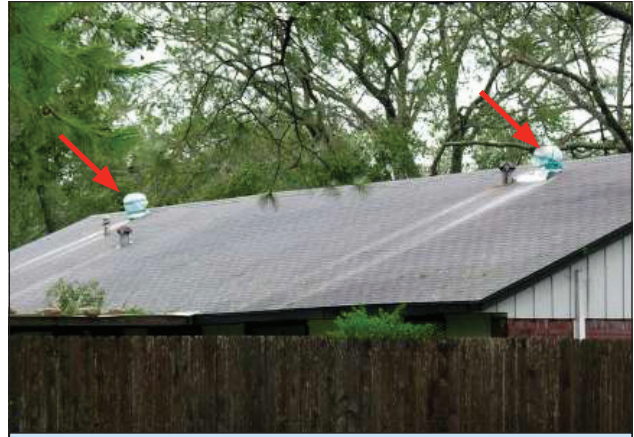
Figure 14. Plastic wrapped turbines.

Beyond any remedial measures taken to anchor the standpipe to the roof sheathing or to plug the hole from the attic side, it is also important to try and seal the standpipe from the outside so that water does not build up in the pipe and leak into the roof sheathing around the hole. The best approach is to have a qualified person remove the top active portion of the turbine vent before the storm and plug the hole at the top of the standpipe. A wooden plug can be used that covers the entire hole and has blocks that rest against the walls of the standpipe where screws can be installed to anchor the plug to the standpipe. Some homeowners have had the entire turbine wrapped in plastic to keep water out during a storm (Figure 14). This can work as long as the turbine or wrapping does not get dislodged. The smaller area provided by removing the turbine top and plugging the hole is considered preferable.
